*PRODUCTION OF
FULGURITES IN THE EARTH
USING
TRIGGERED LIGHTNING*

by MICHAEL MASTERS

ORIGINALLY PUBLISHED BY
DEPARTMENT OF ELECTRICAL
AND COMPUTER ENGINEERING,
UNIVERSITY OF FLORIDA

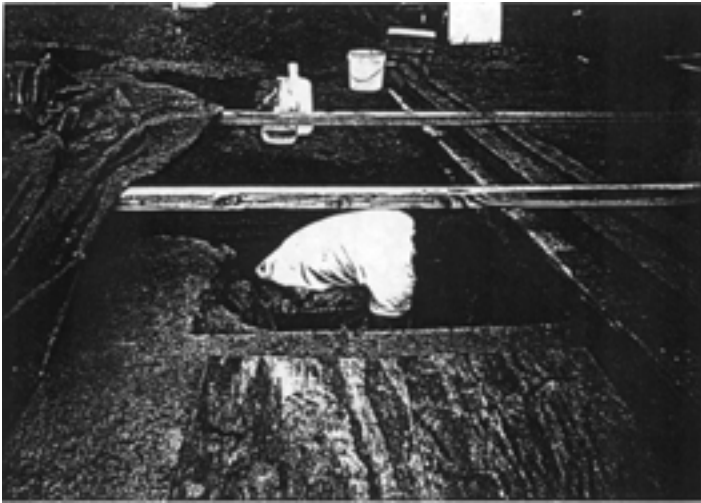
Figure 3: A photograph of the launch site during the excavation; the third fulgurite is barely visible by the shovel.

In May - June 1994, the site was excavated, and the fulgurites were found. The excavation process was a slow, methodical one. The entire launch site, approximately 4 X 20m, was first cleared of the grassy top layer (at the time of the lightnings, there was no vegetation, however, it had grown back during the year between triggering and excavation). Then layer-by-layer the soil was removed until each fulgurite was located. Once the fulgurites were located, archaeological recovery methods were used to remove them. Three complete vertical fulgurites were unearthed, along with numerous branches and fragments.

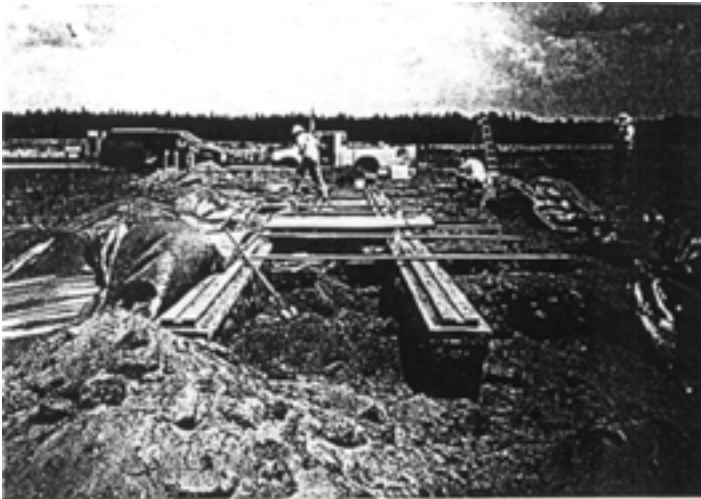
Figure 4: A close-up photograph of the excavation site and the launch rail.

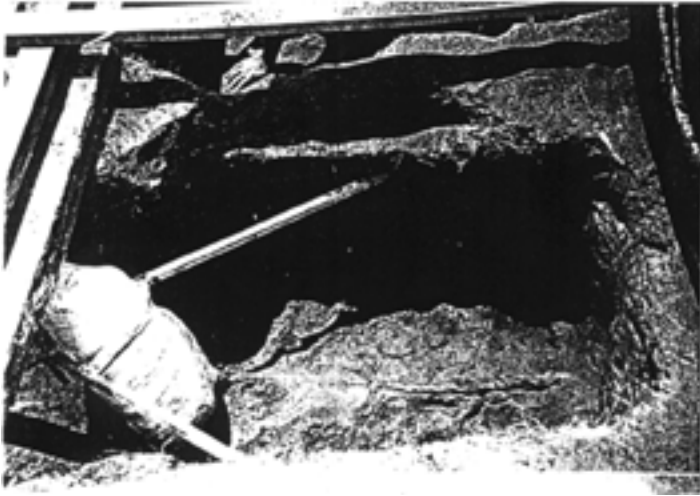
Figure 7: Fulgurite F2 started under the launching rail and terminated at the second buried cable.

The second fulgurite was excavated over the next buried cable. This cable was an exterior shielded cable, but also was damaged by the lightning flash. The fulgurite labeled here F2 is pictured in Figure 7, and is also nearly vertical with a length of approximately 1 meter and an average diameter of 1.5 centimeters at the top and about .4 centimeters at the cable. This fulgurite was the most complete fulgurite excavated, because it was unearthed in one piece with very little reconstruction necessary. F2 also started underneath the concrete rail and traveled

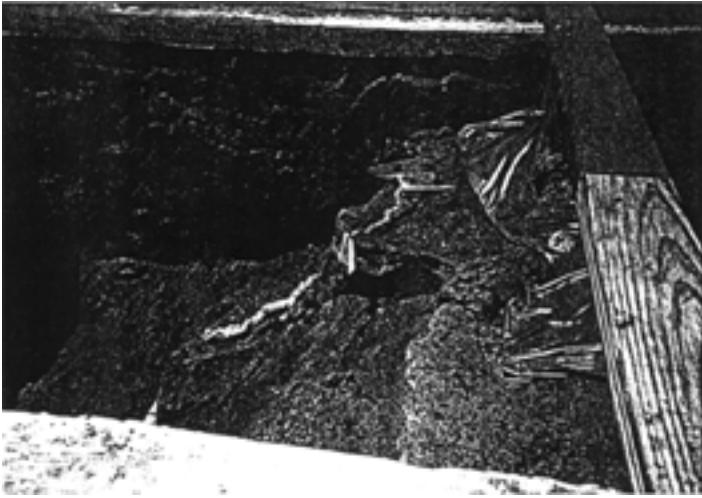
Figure 9: The flat fulgurite found between the fulgurites F2 and F3 underneath the southern concrete slab.

rail. This flat fulgurite was about 2mm thick, 3cm wide, and 5m long, and is pictured in Figure 9. The fulgurites might have connected to the railing because the conductivity of the reinforcement steel rods inside the cement or perhaps the moisture
